Haganes, Arnarlax hf.
B-bottom survey,
June 2020
(fallow period)

Information client			
Titel	Haganes, Arnarlax hf. B-bottom survey, June 2020		
Report number	APN-62254.B01		
Site name	Haganes	Coordinates site	65°40.367 N 023°32.891 V
County		Municipality	Vesturbyggð
MTB-or estimated max biomass	6.672 tonn	Site manager/contact	Silja Baldvinsdóttir
Client name	Arnarlax hf.

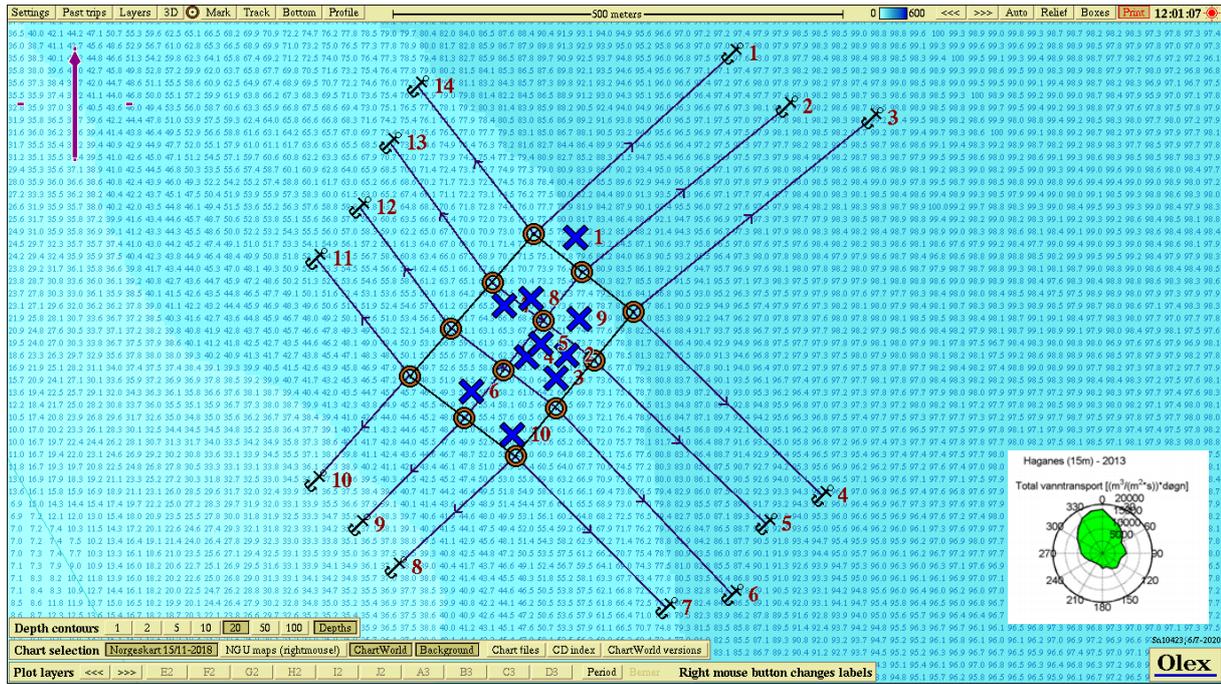
Figure 2. Chart showing depths at the site Haganes. Sampling stations st. 1 – 10 are marked with color codes that describe the condition according to NS 9410:2016, chapter 7.11. Color codes: Blue = very good condition, green = good condition, yellow = bad condition, red = very bad condition.

Description of the stations in the survey is given in Figure 2 and Table 4. Positioning of the stations was chosen based guidance and perimeters described in NS 9410:2016 and the bottom topography and planned configuration of the farm Haganes in Arnarfjörður. Depth at the site is

in the range from about 47 to 83 meters. The placement of sampling stations were chosen to give a good picture of the whole local impact zone in the area with cages that were used during previous production cycle. The sampling stations had a depth varying from 55 m to 81 m. The placement of the sampling stations is regarded to be in accordance with the descriptions for a survey of the local impact zone given in NS 9410:2016. There were planned sampling for up to 19 stations at the site. But due to extensive hard bottom at the site it was strenuous and time consuming work to collect samples at the site it was decided (by project manager) to reduce the number of stations to 10. Drift of the boat added to the difficulty that at the time of sampling as there was only one cage installed that we could anchor the work boat to.

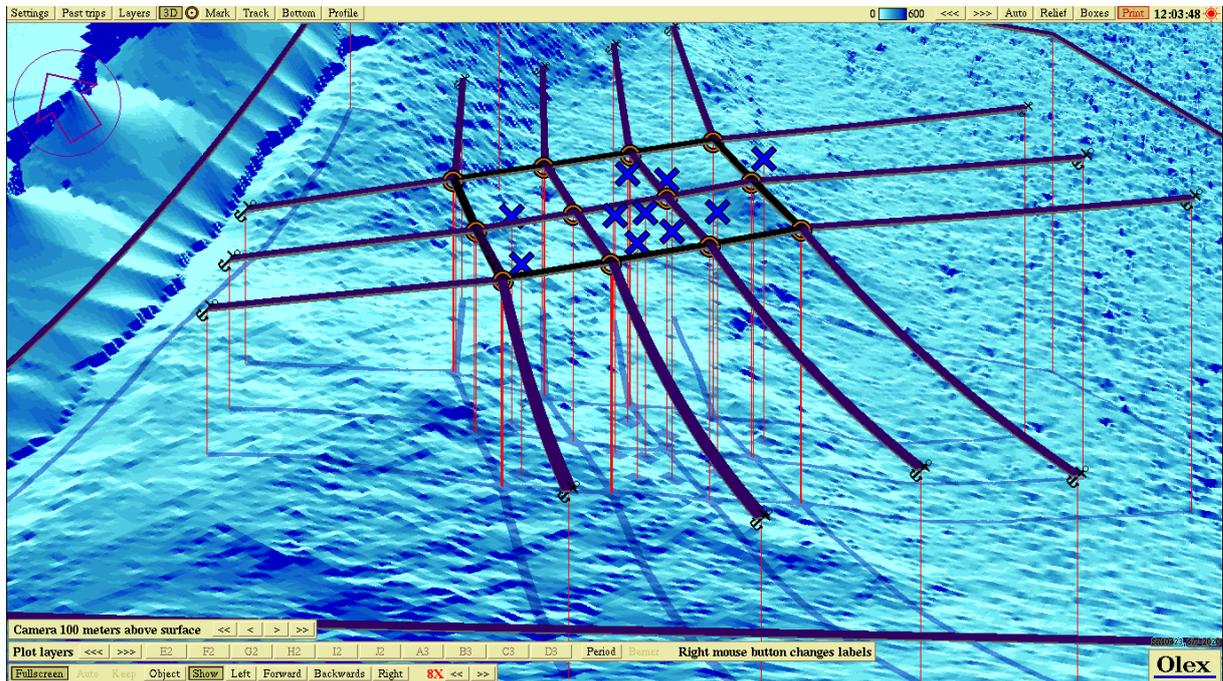
Figure 3. Showing bottom topography 3D at Haganes with each sampling station according to info in figure 2 and Table 3.
