Hvestudalur, Arctic Sea Farm
B survey,
May 2022
(baseline – new site)

Information client			
Title	Hvestudalur, Arctic Sea Farm. B survey (baseline – new site) , May 2022		
Report number	APN-64085.B01		
Site name	Hvestudalur	Coordinates site	65°42,845N 023°38,963V
County	Barðastrandarsýsla	Municipality	Vesturbyggð
MTB-or estimated max biomass	3.900 tonnes	Site manager/contact	Steinunn G Einarsdóttir
Client name	Arctic Sea Farm

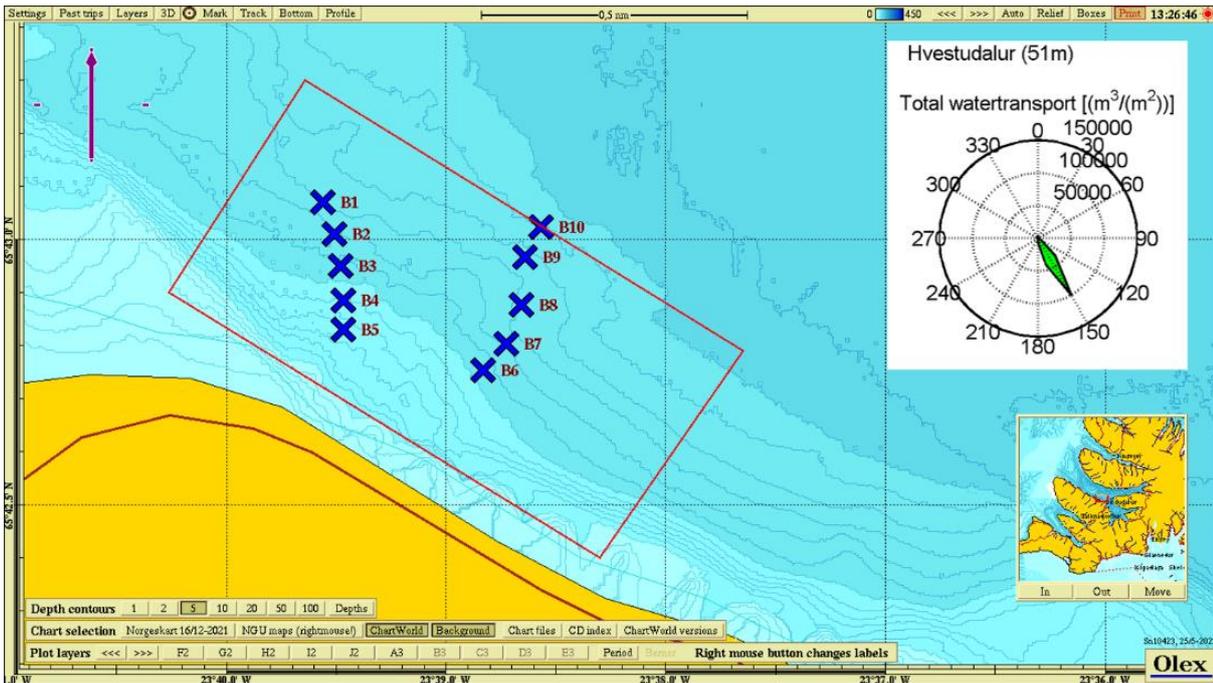
The placement of the 10 sampling stations is shown in Figure 2 with GPS positions listed in Table 2. Stations are distributed within the near zone of the new frame position following criteria outlined in NS 9410:2016. Depth beneath and in the close vicinity of the cages varies between 56–88 m, with the deepest waters being located in northern part of the frame. Sampling stations were placed to represent the varied environmental conditions within the near zone and cover thus both the deeper and shallower areas. The sampling stations had a depth varying from 40 to 90 m. The placement of sampling stations is regarded to be in accordance with the requirements outlined in NS 9410:2016.

Figure 2. Site specific map of Hvestudalur showing the proposed farming area. Sampling stations B1 – 10 are marked with crosses. The color of each cross represents the environmental condition at the respective station following the classification as outlined in NS 9410:2016, chapter 7.11. Colour codes: blue = very good, green = good, yellow = bad, red = very bad. Current rose placed in the top right corner shows main current direction at 51 m (Gustavsson, 2022).

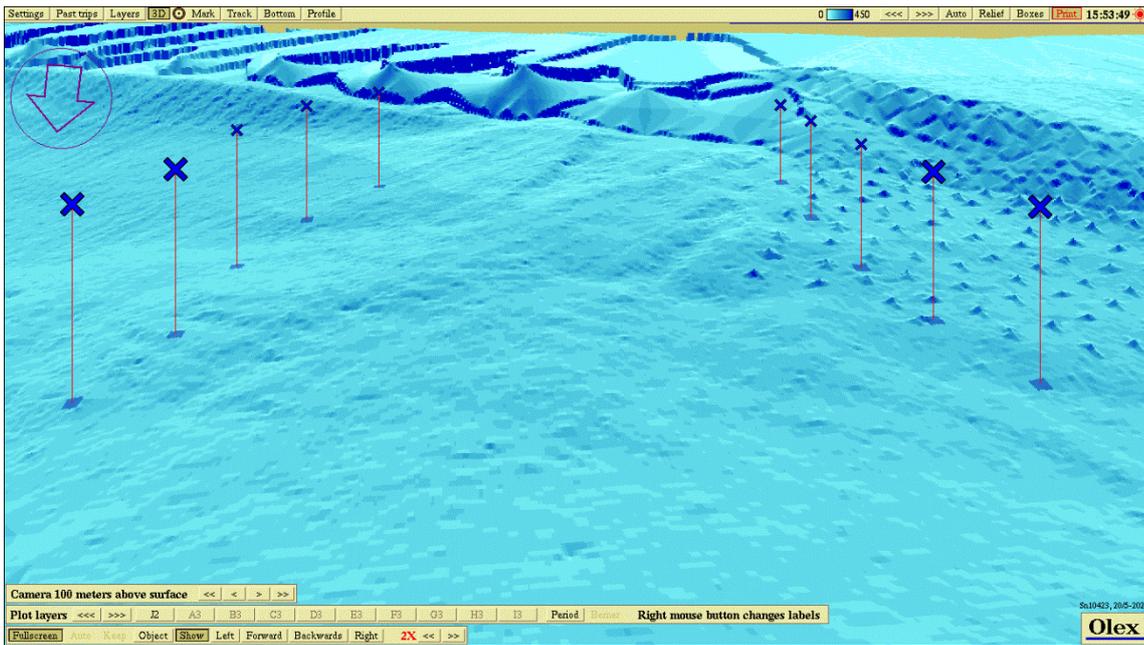
Figure 3. Bottom topography in 3D at Hvestudalur with each sampling station according to info in Figure 1 and Table 2.
