B-survey at Tjaldanes, 2026 (max biomass), Arnarlax ehf

Akvaplan-niva AS Report:
APN 2026 67226.B01

B survey at Tjaldanes 2026 (max biomass), Arnarlax ehf

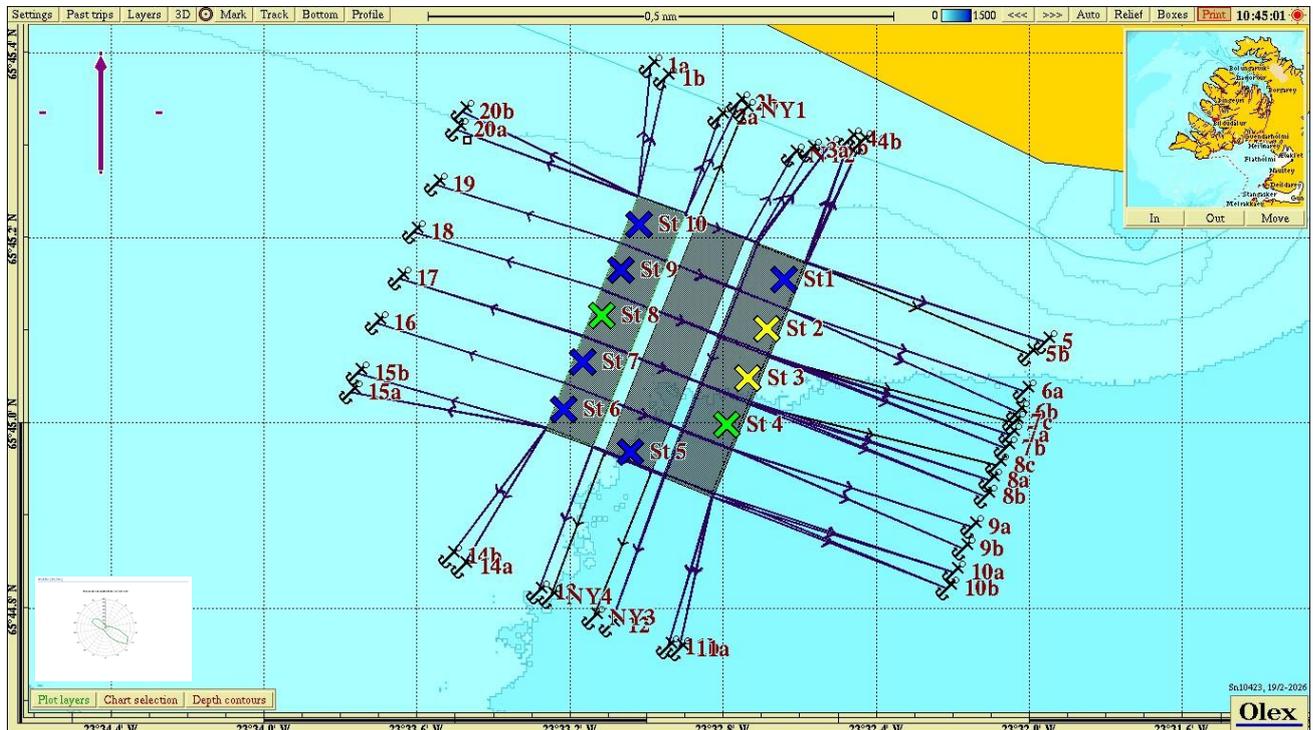
Figure 2. Overview map showing site configuration and local bathymetry at Tjaldanes. Sampling stations are marked by crosses and colour coded to visualise the environmental status at the respective station following the classification outlined in NS 9410:2016, chapter 7.11 (1 = blue, 2 = green, 3 = yellow, 4 = red). The current rose in the left corner shows the direction of water transport of the dispersal current at 60 m depth (Moe and Ottesen, 2014).

Sampling stations were placed following an assessment of site configuration and local environmental conditions, i.e. bathymetry and hydrodynamics. An overview of the sampling stations can be found in Figure 2 with coordinates and depth provided in Table 4. The number of sampling stations were 10 according to guidance in ISO 12878 and NS 9410:2016. The placement of the sampling stations gives good coverage of the local impact zone of the fish farm. Sampling stations were placed to represent the environmental conditions within the near zone and cover thus

both the deeper and shallower areas. The deeper areas are further into the fjord in the southern and eastern part of the fish farming area. The depth in the local impact zone is in the range from about 60-104 m. Samples were collected from depths ranging from 69-103 metres. The station placements are considered representative for an environmental survey of the farm's near-zone and in accordance with the requirements outlined in NS 9410:2016.

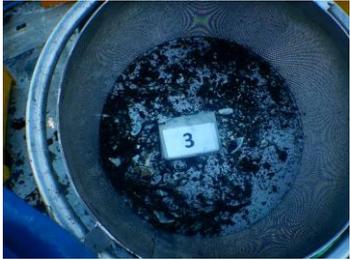
| <i>St</i> | <i>Image before sieving</i> | <i>Image after sieving</i> |
|---|---|--|
| <i>St 3</i> | | |

| Sample number | 1 | 2 | 3 | 4 | 5 | 6 | 7 | 8 | 9 | 10 |
|---|---|---|---|---|---|---|---|---|---|---|
| Comments | St. 3. black and oily - beggiotoa | | | | | | | | | |

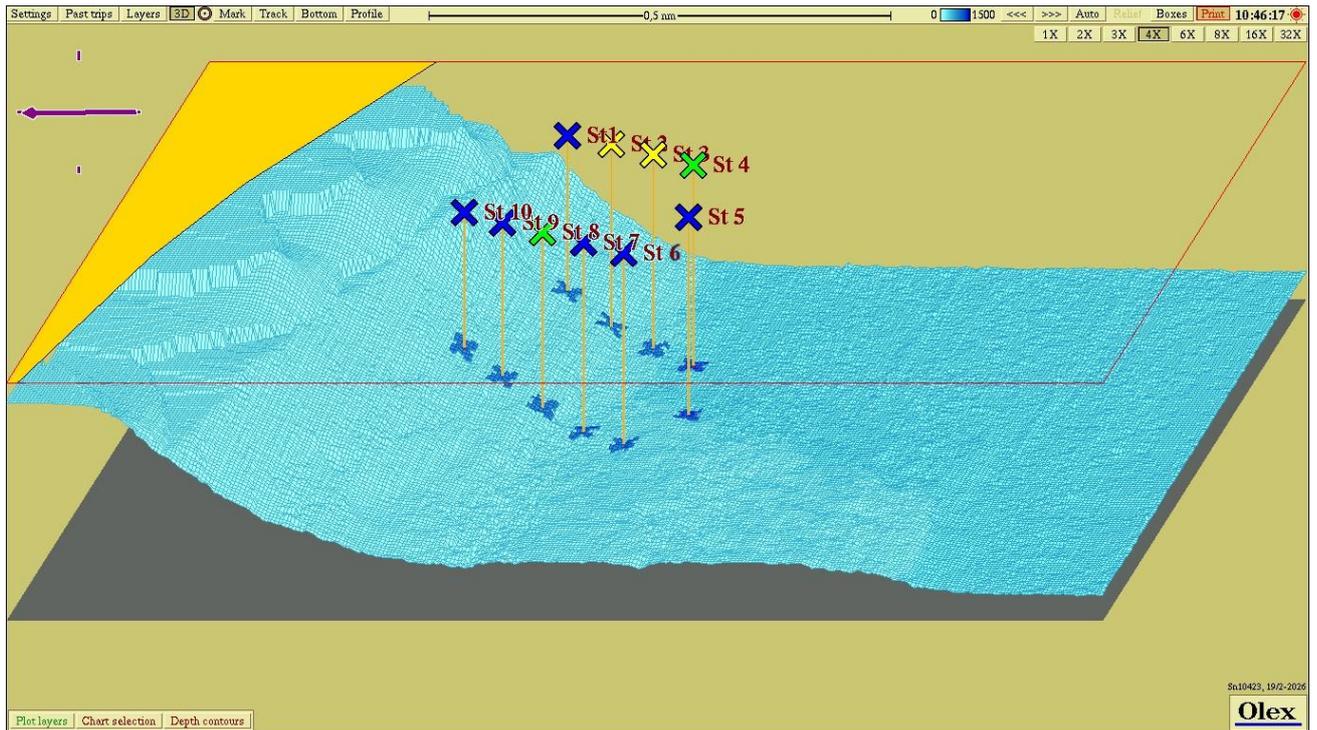
Figure 3. 3D-view of bathymetry at Tjaldanes with stations as shown in Figure 2 and Table 4. The map is oriented towards the west.
